# Safety Share:

Activity: Ground IP

Location: SE Peru

#### Date: May 2015

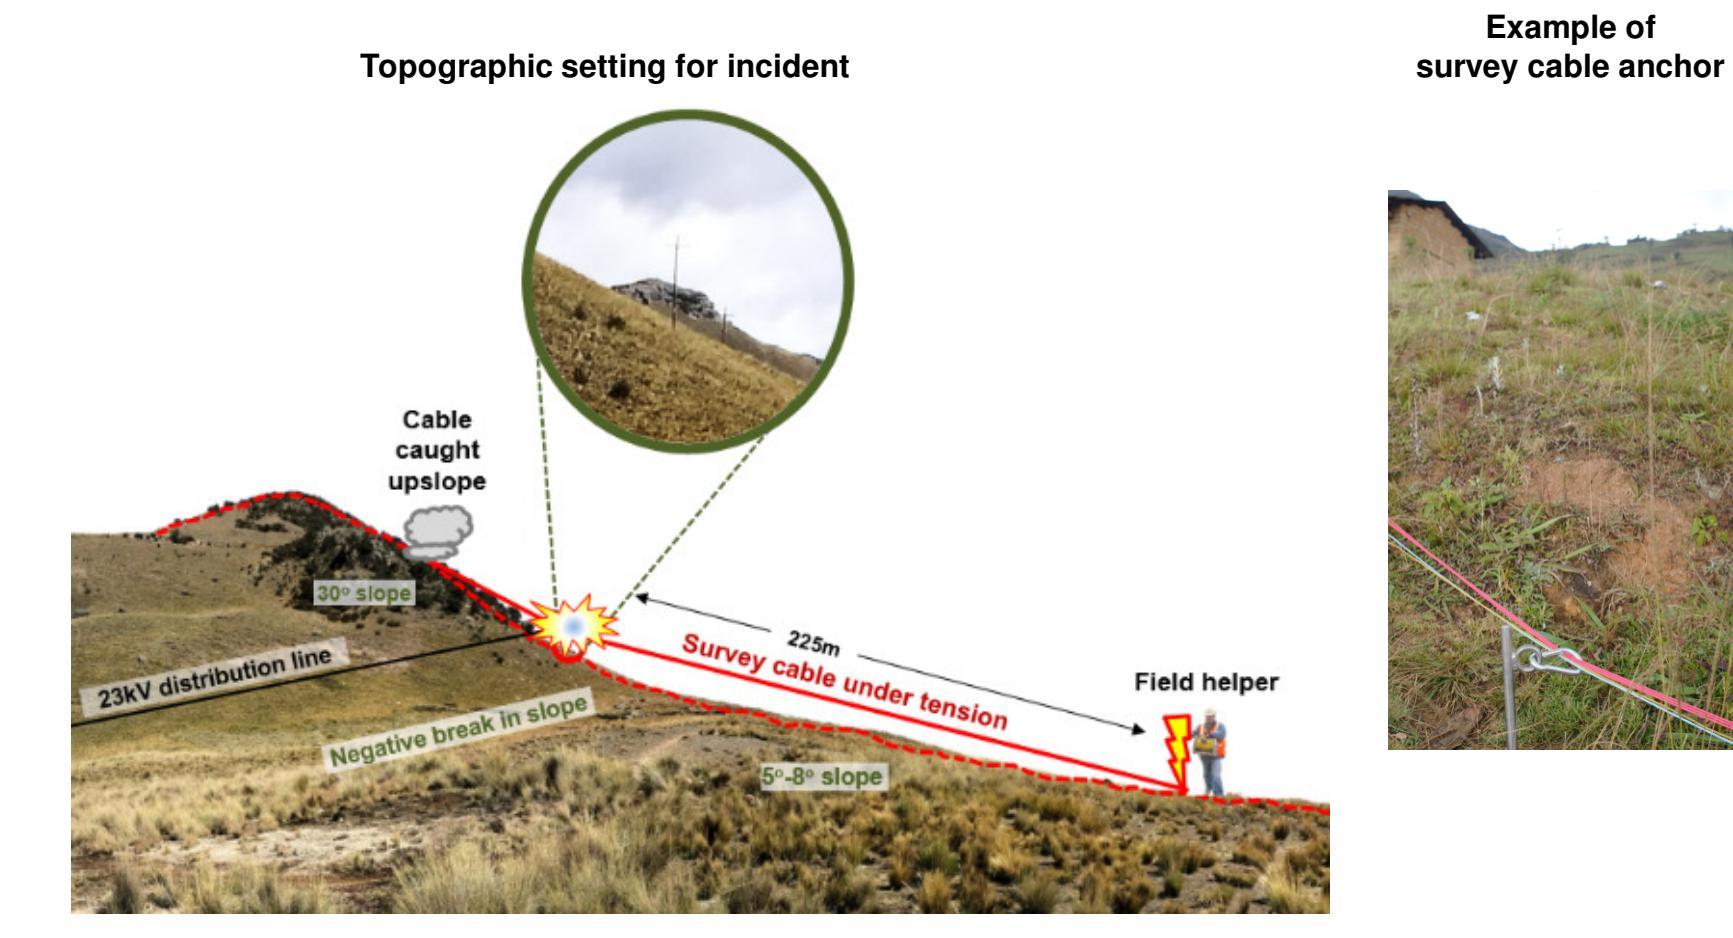
What happened: While a locally hired field worker was collecting a survey cable from the field using a chest mounted reel, the cable snagged on rocks and brush. The worker pulled on the cable in an attempt to release it. The action of pulling the cable, combined with the effect of local topography, resulted in the cable lifting off the ground and contacting an overhead 23kV powerline, 225m upslope from the worker's position. The worker was knocked to the ground and received a single minor burn.

- Local topography created the conditions that allowed the cable to rise >7m above ground surface when under tension
- Neither the location of the overhead powerline nor the path of survey cable was visible from the workers position
- The presence of the overhead powerline had not been identified during either project planning or daily pre-start risk assessments
- Approaching cattle and alpaca encouraged the worker to collect the cable from the field (to eliminate the risk of damage)
- Survey supervisors were located out of sight of the worker

- All cables that pass beneath overhead utility lines to be securely anchored to the ground
- The presence of powerlines to be identified during the survey planning stage (and incorporated into survey risk assessments)
- The value of wearing electrically insulating footwear is undefined but assumed to have helped protect the worker
